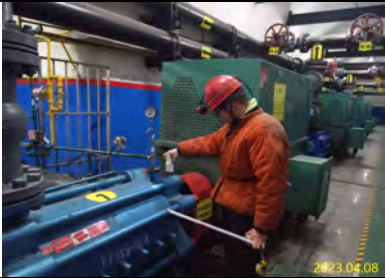
| 158 | GX-B1499/21-3-23061 | 2023/4/26 | 所检项目合格 | |

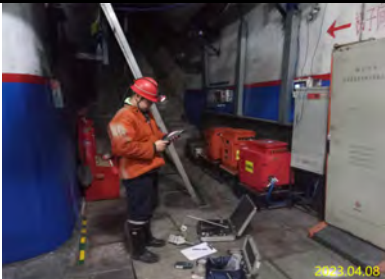
| 159 | GX-B1499/21-3-23062 | 2023/4/26 | 所检项目合格 | |

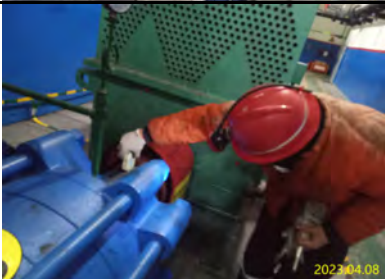
| 160 | GX-B1499/21-3-23063 | 2023/4/26 | 所检项目合格 | |

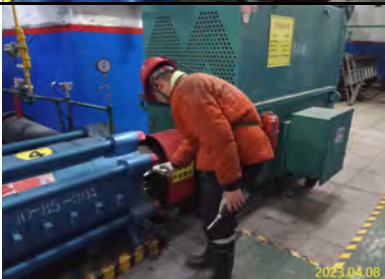
| 161 | GX-B1499/21-3-23064 | 2023/4/26 | 所检项目合格 | |

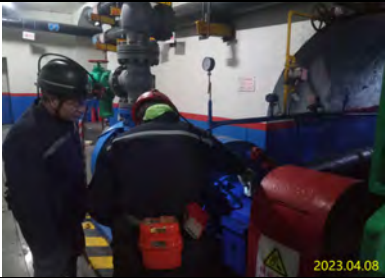
| 162 | GX-B1499/21-3-23065 | 2023/4/26 | 所检项目合格 | | |

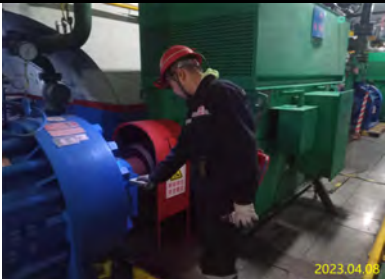
| 163 | GX-B1499/21-3-23066 | 2023/4/26 | 所检项目合格 | | |
