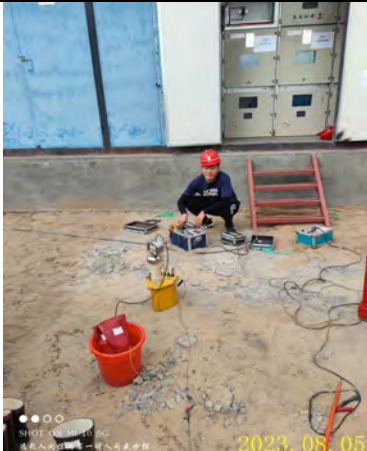
33	GX-B1328/20-5-23146	2023. 8. 15	本次共检绝缘手套6只，6只绝缘手套合格。

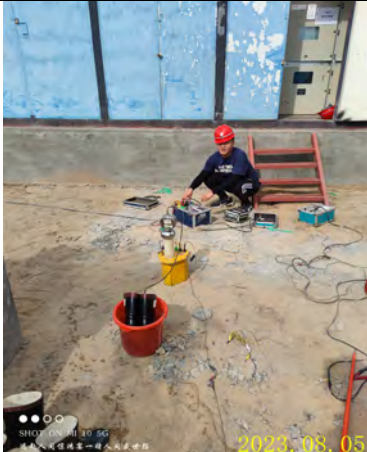
34	GX-B1328/20-5-23147	2023. 8. 15	本次共检绝缘鞋6只，6只绝缘鞋合格。

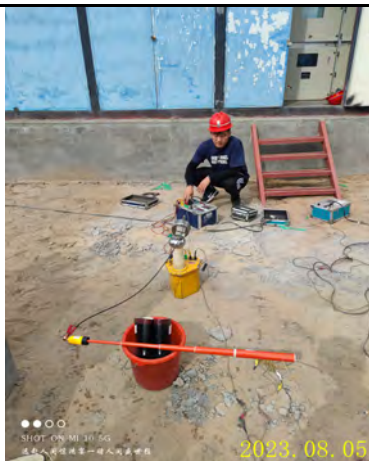
35	GX-B1328/20-5-23148	2023. 8. 15	所检项目合格。

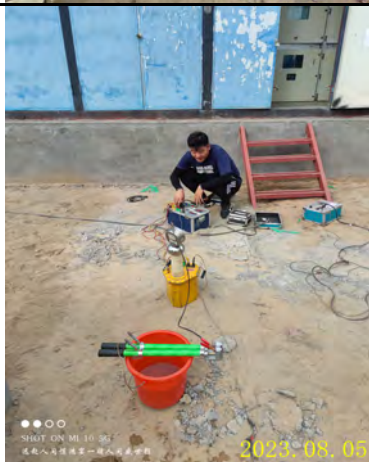
<p>SHOT ON MI 10 5G 2023.08.05</p>
36	GX-B1328/20-5-23149	2023. 8. 15	所检项目合格。

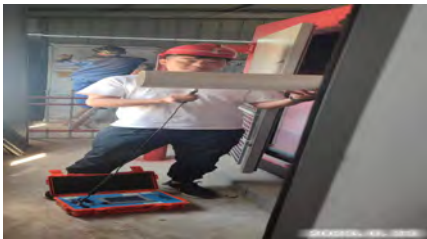
51	GX-B1306/21-5-23059	2023. 8. 18	所检项目合格

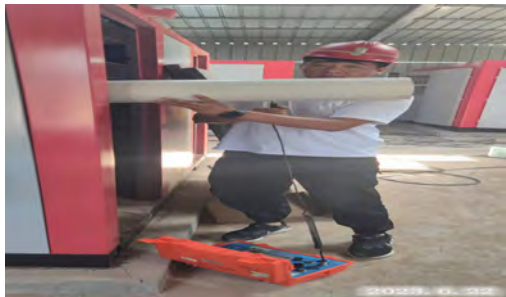
52	GX-B1306/21-5-23060	2023. 8. 18	所检项目合格

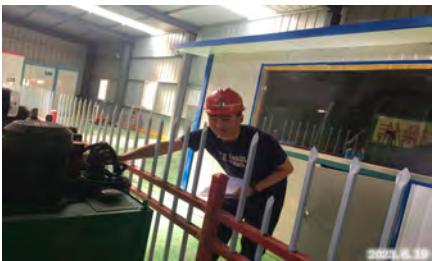
57	GX-B1300/20-5-23023	2023. 8. 18	所检项目合格

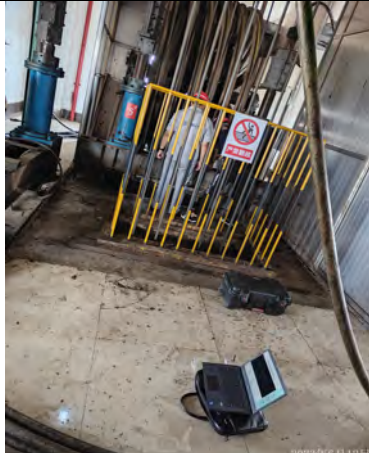
63	GX-B1598/21-5-23053	2023/8/23	实测钢丝绳有效截面积损失百分比最大为2.68%，小于5%为正常。	 
64	GX-B1598/21-5-23054	2023/8/23	实测钢丝绳有效截面积损失百分比最大为1.76%，小于5%为正常。
