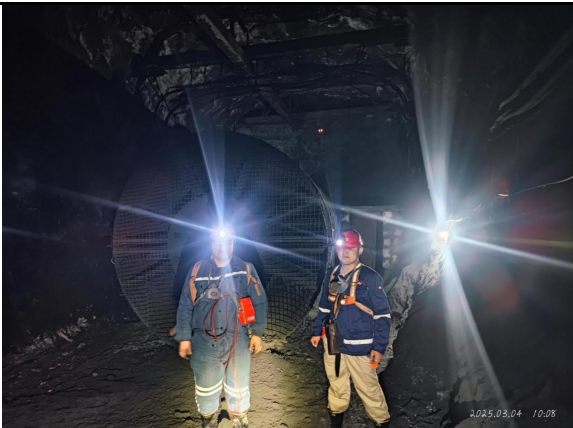
A photograph showing two workers in blue and yellow safety gear standing in a dark tunnel. They are positioned in front of a large circular mesh gate. The workers' headlamps are on, illuminating the scene. A timestamp '2025.03.04 10:08' is visible in the bottom right corner.
23	GX-B1341/24-8-25009	2025.3.14	综合判定：合格。

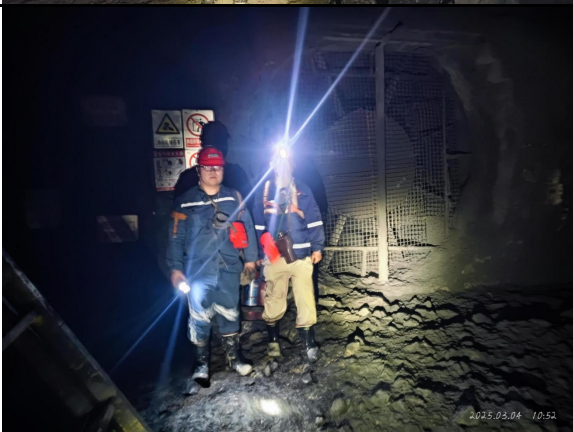
A photograph of two workers in safety gear standing in a tunnel. They are in front of a mesh gate with several warning signs attached to it. The workers' headlamps are on. A timestamp '2025.03.04 10:52' is visible in the bottom right corner.
24	GX-B1341/24-8-25010	2025.3.14	综合判定：合格。

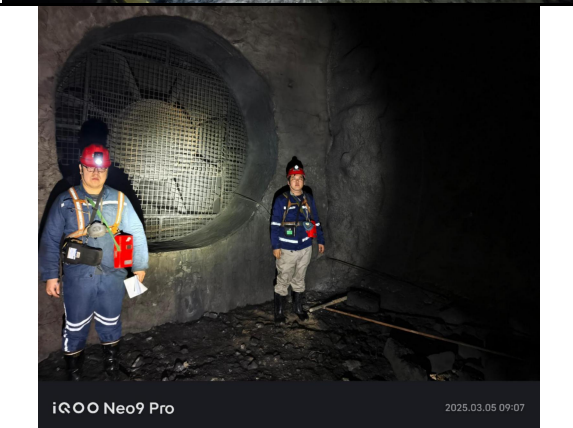
A photograph showing two workers in safety gear standing in a tunnel. They are positioned in front of a circular mesh gate. The workers' headlamps are on. A watermark 'iQOO Neo9 Pro' is visible in the bottom left corner, and a timestamp '2025.03.05 09:07' is in the bottom right corner.

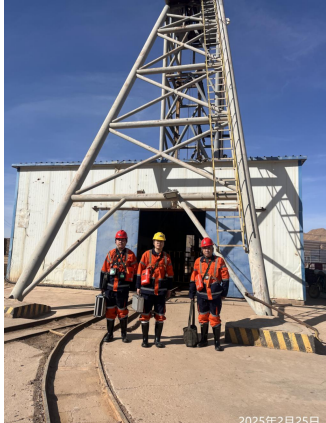
<p style="text-align: right; font-size: small;">2025年2月26日</p>
38	GX-B1343/21-8-25001	2025. 3. 20	<ol style="list-style-type: none"> 1. 矿井总风量：3836.2 m³/min； 2. 主通风机风量：4055.4 m³/min； 3. 矿井通风阻力：1号风井系统1318.1Pa；2号风井系统1057.4Pa； 4. 风量（风速）合格率：100%，大于65%，合格； 5. 风质合格率：100%，大于90%，合格； 6. 作业环境空气质量合格率：100%，大于60%，合格； 7. 矿井有效风量率：66.9%，大于60%，合格； 8. 风机全压效率：70.6%，大于70%，合格； 9. 风量供需比：1.65，符合$1.32 \leq \beta \leq 1.67$要求，合格； 10. 综合指标：88.2%，大于72%，合格。

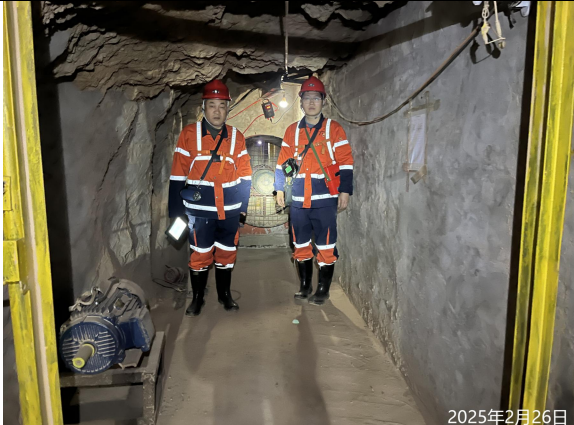
<p style="text-align: right; font-size: small;">2025年2月25日</p>
39	GX-B1343/21-8-25002	2025. 3. 20	<ol style="list-style-type: none"> 1. 矿井总风量：930.6m³/min； 2. 主通风机风量：981.0 m³/min； 3. 矿井通风阻力：526.1Pa； 4. 风量（风速）合格率：100%，大于65%，合格； 5. 风质合格率：100%，大于90%，合格； 6. 作业环境空气质量合格率：100%，大于60%，合格； 7. 矿井有效风量率：74.4%，大于60%，合格； 8. 风机全压效率：75.7%，大于70%，合格； 9. 风量供需比：1.58，符合$1.32 \leq \beta \leq 1.67$要求，合格； 10. 综合指标：90.9%，大于72%，合格。

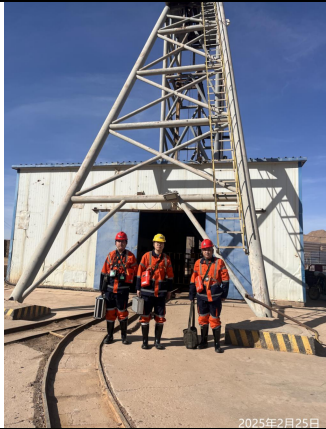
40	GX-B1347/21-8-25001	2025. 3. 20	<ol style="list-style-type: none"> 1. 风量（风速）合格率：100%，大于65%，合格； 2. 风质合格率：100%，大于90%，合格； 3. 作业环境空气质量合格率：100%，大于60%，合格； 4. 矿井有效风量率66.9%，大于60%，合格； 5. 风机全压效率为70.6%，大于70%，合格； 6. 风量供需比1.65，符合$1.32 \leq \beta \leq 1.67$要求，合格； 7. 综合指标88.2%，大于72%，合格。

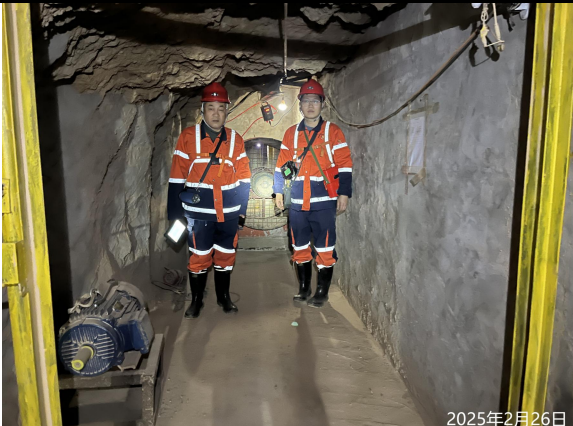
<p style="text-align: right; font-size: small;">2025年2月25日</p>
41	GX-B1347/21-8-25002	2025. 3. 20	<ol style="list-style-type: none"> 1. 风量（风速）合格率：100%，大于65%，合格； 2. 风质合格率：100%，大于90%，合格； 3. 作业环境空气质量合格率：100%，大于60%，合格； 4. 矿井有效风量率74.4%，大于60%，合格； 5. 风机全压效率为75.7%，大于70%，合格； 6. 风量供需比1.58，符合$1.32 \leq \beta \leq 1.67$要求，合格； 7. 综合指标90.9%，大于72%，合格。
